LAKE GORDON DAM, (NDS-242), 11

PHASE I INSPECTION REPORT

BERGER ASSOCIATES, INC
CONSULTING ENGINEERS
HARRISBURG, PA.

Name of Dam: LAKE GORDON DAM
State and State Number: PENNSYLVANIA - 5-1
County: BEDFORD
Stream: EVITTS CREEK, POTOMAC RIVER BASIN
Date of Inspection: APRIL 25, 1978

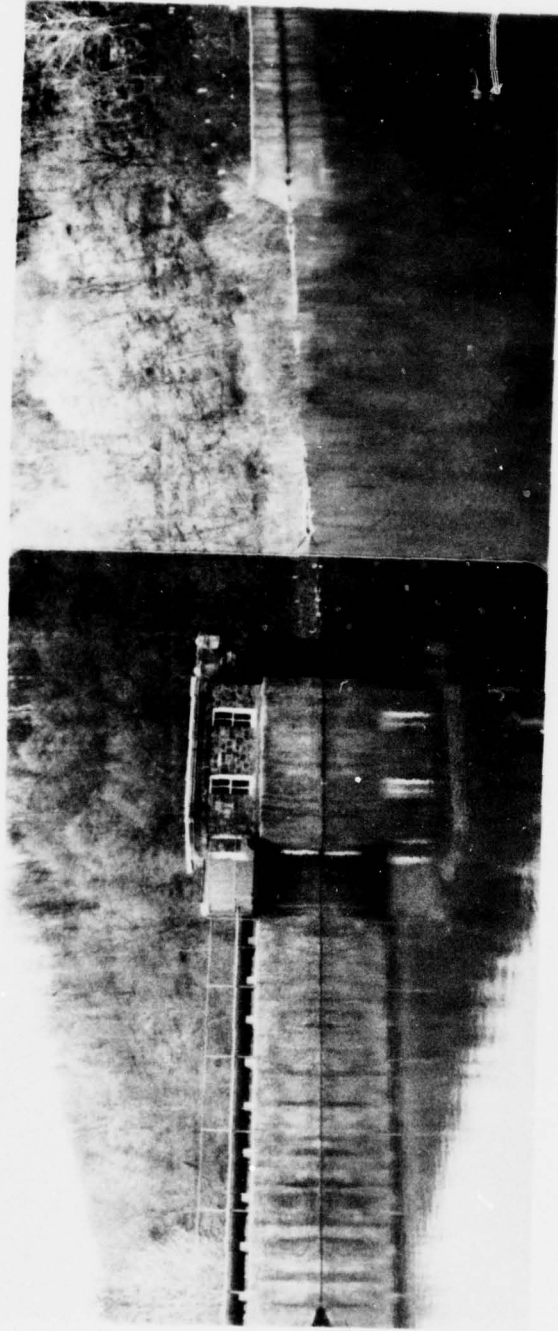
Upstream Face of Dam

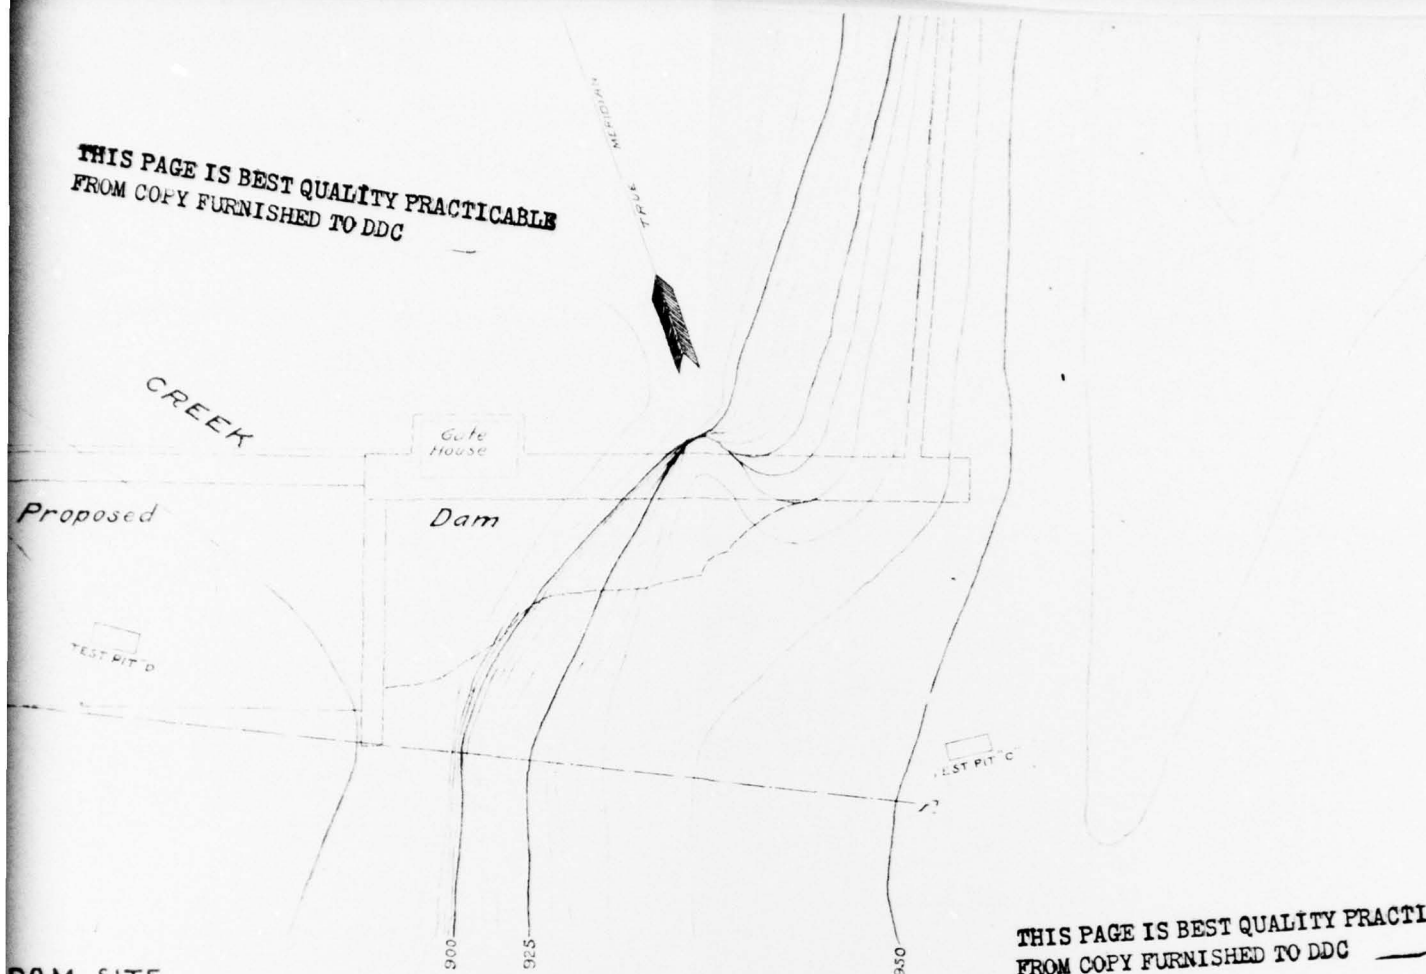
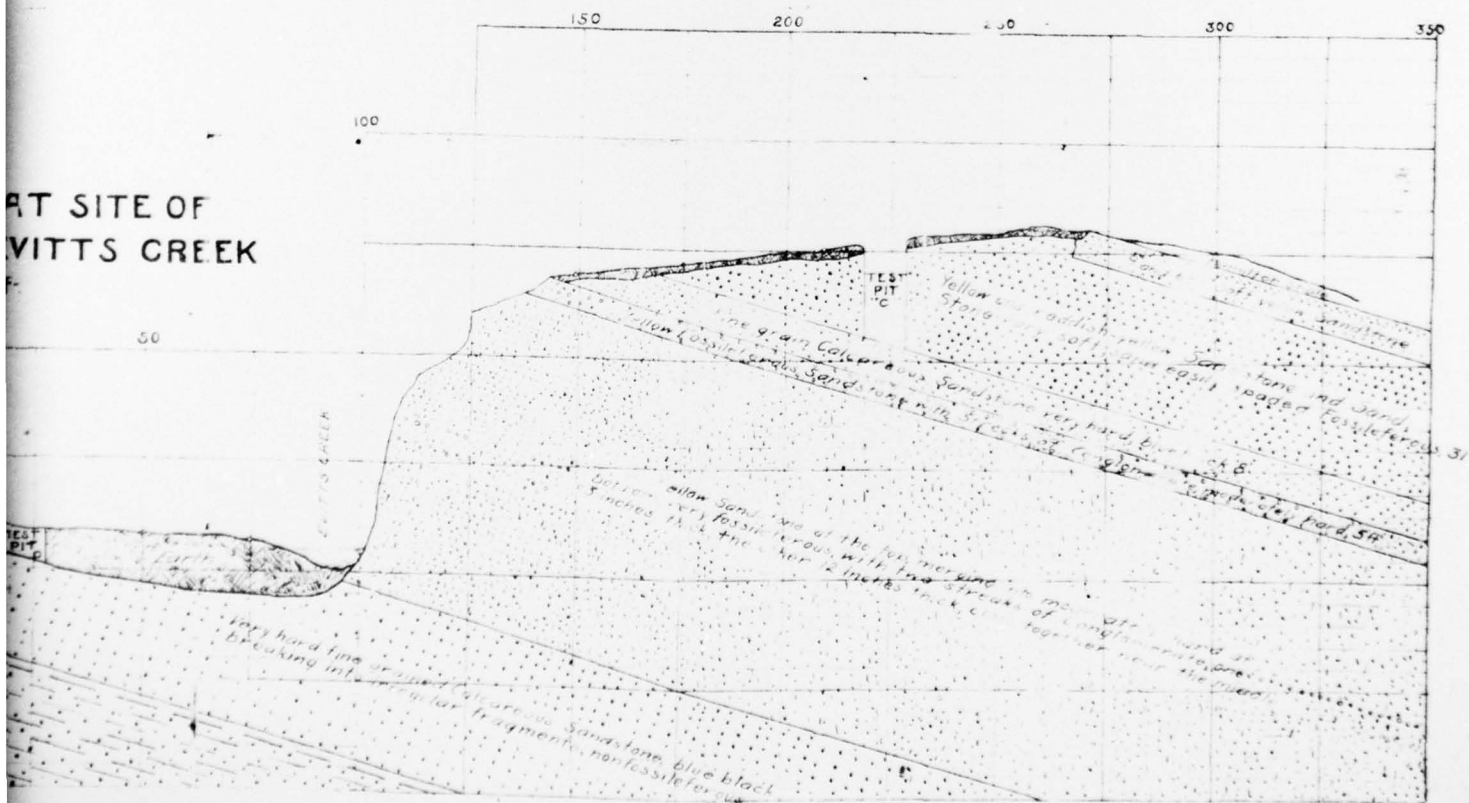
PLATE VII 2

The design drawings contain a geological section along a line near the centerline of the dam (Appendix D, Plate VII). The proposed dam on this drawing is not in the final location, but was constructed approximately along line A-A. Some test pits were excavated, but there was no information on the results. The dam was specified to be founded on "firm" foundation. Refer to Appendix D, Plate X for a loci of the resultants for the various loading conditions.

The design drawings indicate the general construction information and the design assumptions. A maximum toe pressure of 4.84 tons per square foot is indicated. The location of the dam was based on a geological investigation and moved slightly southward from the original location due to the existence of a weak foundation strata.
